## STUDIES OF THE SIRKO RAVINE IN ORDER TO PREVENT THE DEVELOPMENT OF LANDSLIDE-HAZARDOUS PROCESSES

<sup>1</sup>Zmievskaya K.O.

<sup>1</sup>*Institute of Geotechnical Mechanics named by N. Poljakov of NAS of Ukraine*

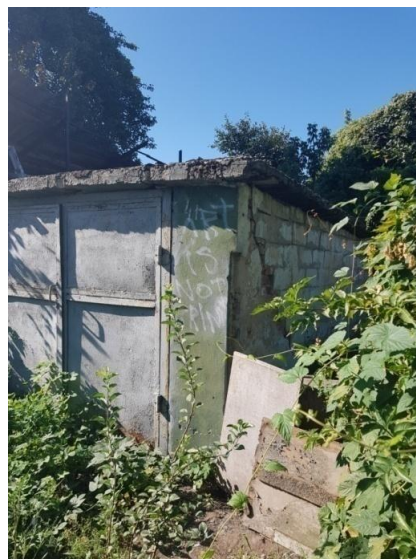
In fig. 4 a, b shows examples of the destruction of the fences of the household farmsteads located on the Lastochkina, 48 str. The location of these observation points on the satellite map is shown in fig. 5 b.

Figure 4 - Deformation of structures on the Lastochkina, 48 str.

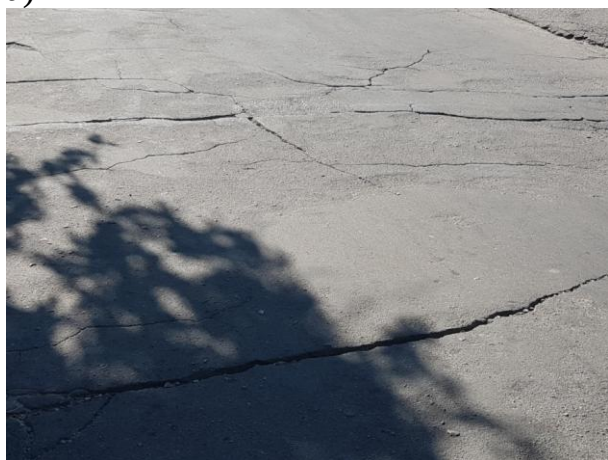
In addition to violations of buildings and fences, deformations are observed on the asphalt pavement on the Sirko str. and Lastochkina str., separation cracks, which show the direction towards the Dovha ravine (Fig. 5 a, b).

Figure 5 - Cracked asphalt pavement on the Sirko, 47 str. (a) and the position of observation points on a satellite map (b)

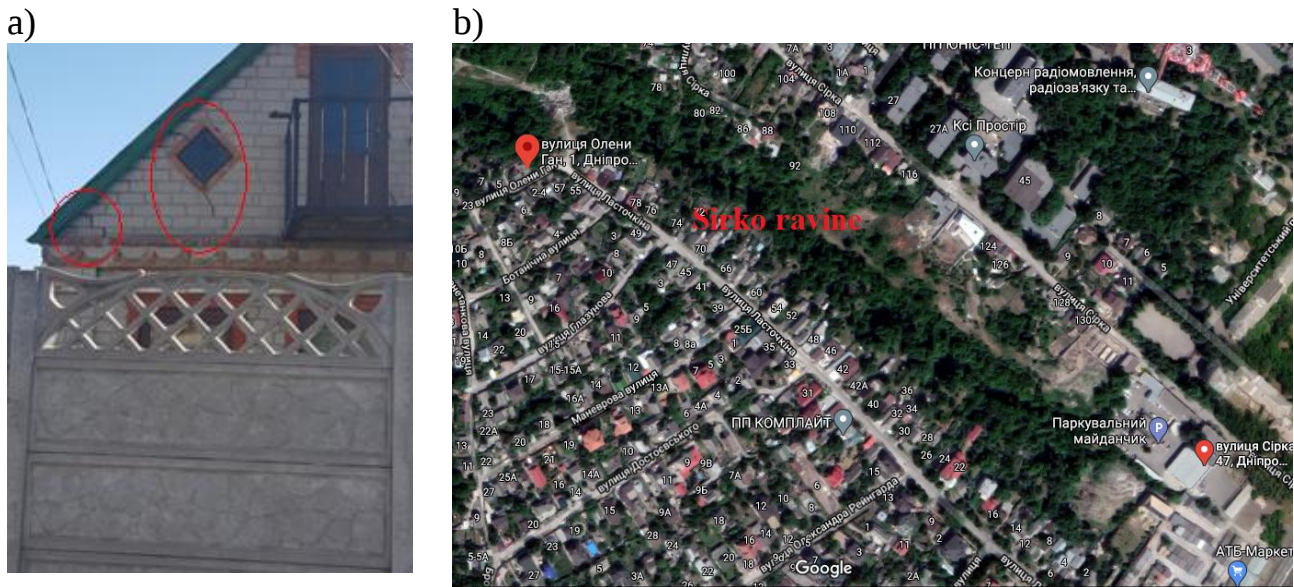
An example of deformations of buildings, as well as the position of observation points on a satellite map on the Olena Han, 1 str. is shown in Fig. 6 a, b.

Figure 6 - Deformations of the walls of the house (a) and the position of observation points on the satellite map (b)
